The Mortenson Ranch Story: Balancing Environment and Economics

**W. Carter Johnson
Malia A. Volke**

Department of Natural Resource Management
South Dakota State University
Brookings, South Dakota

P-00290, formerly 07-5000-2015

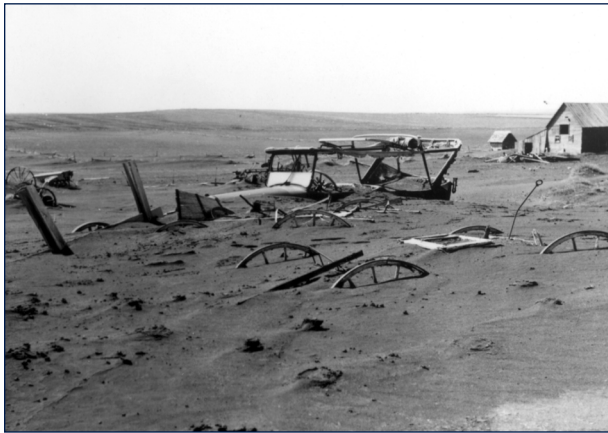
Figure 4a. Buried machinery in barn lot, Nelsen farm in Gregory County, South Dakota. Photo courtesy of South Dakota Agricultural Heritage Museum Photograph Collection, image number 85:48:14.

Cleaning up the old homestead sites had first priority. Most of the settlers' fencerows were still buried above the top wire with soils that had blown from the abandoned fields and overgrazed rangelands (Figure 4a,b). Almost every quarter section had been fenced, and the area was littered with downed posts and wire scattered throughout by horses and cattle getting tangled and cut up over the years. All of the sites remained as they were in the mid-1930s when they were abandoned. Nearly 40 families homesteaded on what is now the ranch headquarters (ca. 10,000 acres; Figure 5). The condition of the vegetation at the end of the drought was dismal, with every acre overgrazed or farmed and abandoned. Cool season grasses had disappeared on the alluvial soils and warm season grasses were severely depleted. Woody plants had been burned for cooking and heating and cut for fence posts and corrals. Any new plant reproduction was grazed off. Overgrazing assured that any seed that germinated would be consumed before it was a foot high and soon there were no seed sources. By the time the last settlers left in the late 1930s even the chokecherry and plum thickets had been used for fuel. Aging of the largest trees (green ash) in the 1990s determined that they had germinated in the 1930s when the settlers were departing. While tearing down a dilapidated settler shanty, Clarence saw the first deer (a stuffed wall mount) he had ever seen in West River country. Later his saddle horse spooked upon seeing its first living deer.

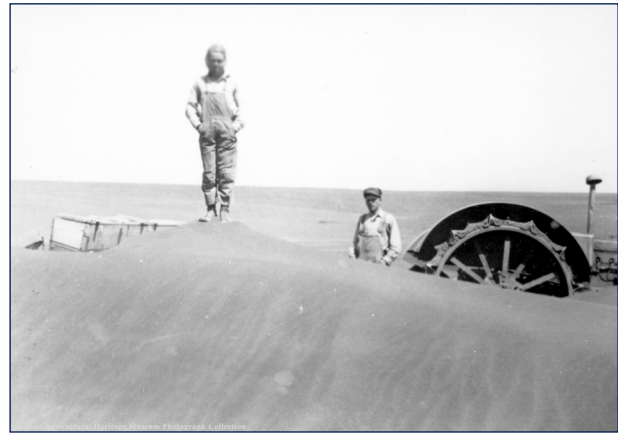
Figure 4b. Child standing on drifted soil circa 1930s. Photo courtesy of South Dakota Agricultural Heritage Museum Photograph Collection, image number 76:26:16.

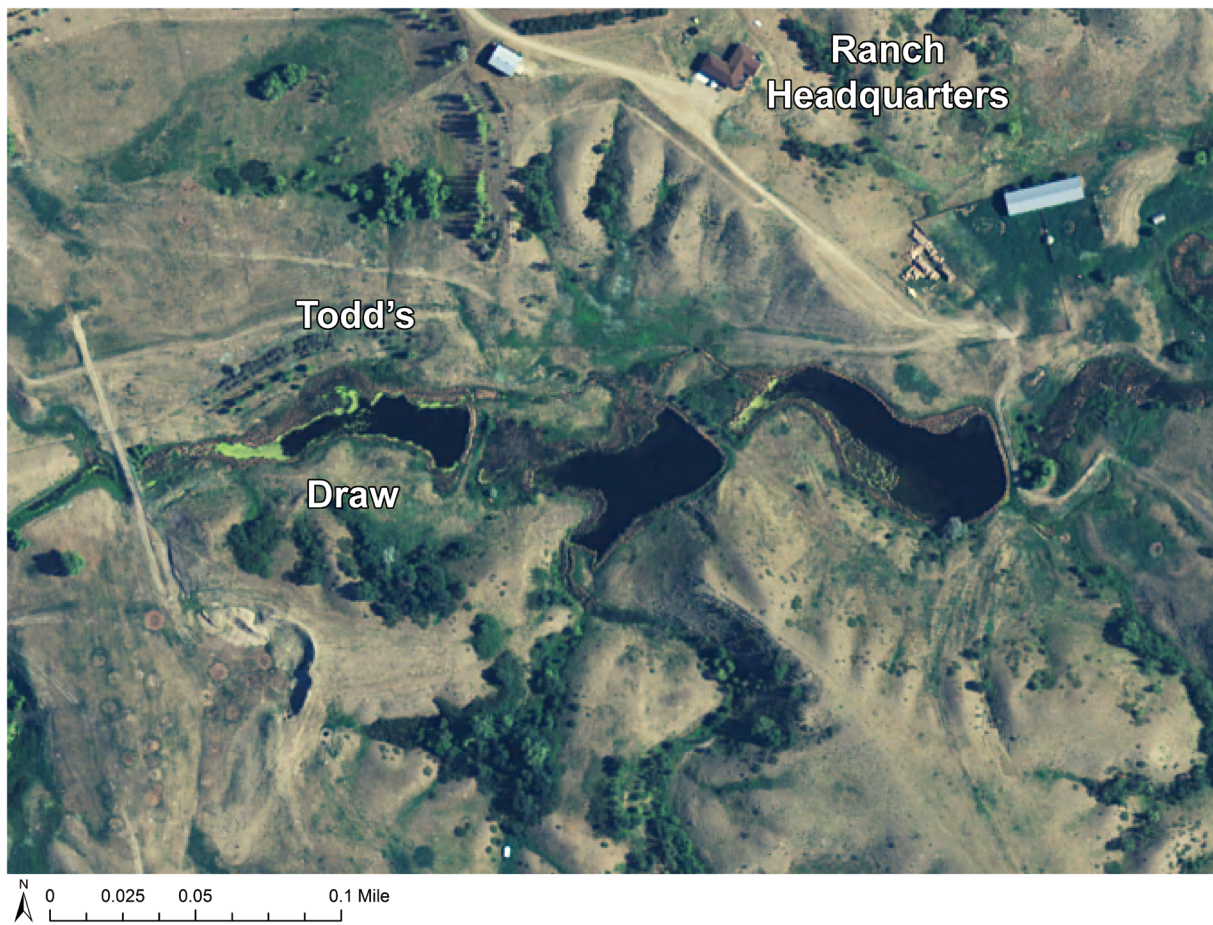
Figure 10. Location of "speed bump" dams in Todd's Draw on the Mortenson Ranch Home Place. Image Source: U.S. Department of Agriculture, National Agriculture Imagery Program (2012).

was of particular concern because it was advancing near the gravel beds (former Cheyenne River channels) atop the shale that served as an aquifer draining 2,000 acres of land. Several dams (Figure 10) were constructed to slow runoff and divert it into the underground gravels rather than above ground through the stream course. Some of these dams held, some cut through and were rebuilt, and some filled with sediment. A spreader dam system (Figure 11) was added later to hold back more water from the upper watershed and give it time to leak into the gravels below the larger dams. The eventual outcome of this dam building during the late 1940s and 1950s was to direct more water underground than through the stream in Todd’s Draw as a means of slowing or altogether stopping the gullying and keeping the groundwater on the ranch longer to support plant growth in riparian areas. Clarence had learned from experience that trees along the streams cannot survive dry years unless the streamside aquifers are restored. Trees hand-planted throughout the 1950s along the stream all died during a dry period in the late 1950s that ended in 1961, a year with almost no moisture. This system of dams has worked so well that today very little water flows down Todd’s Draw that has not moved through the gravels. Moreover, the success of the small dams became evident in the early 1970s as trees and shrubs began to cover the banks, and wetland plants such as cattails and prairie cordgrass became established on the once scoured bottoms of the water course.

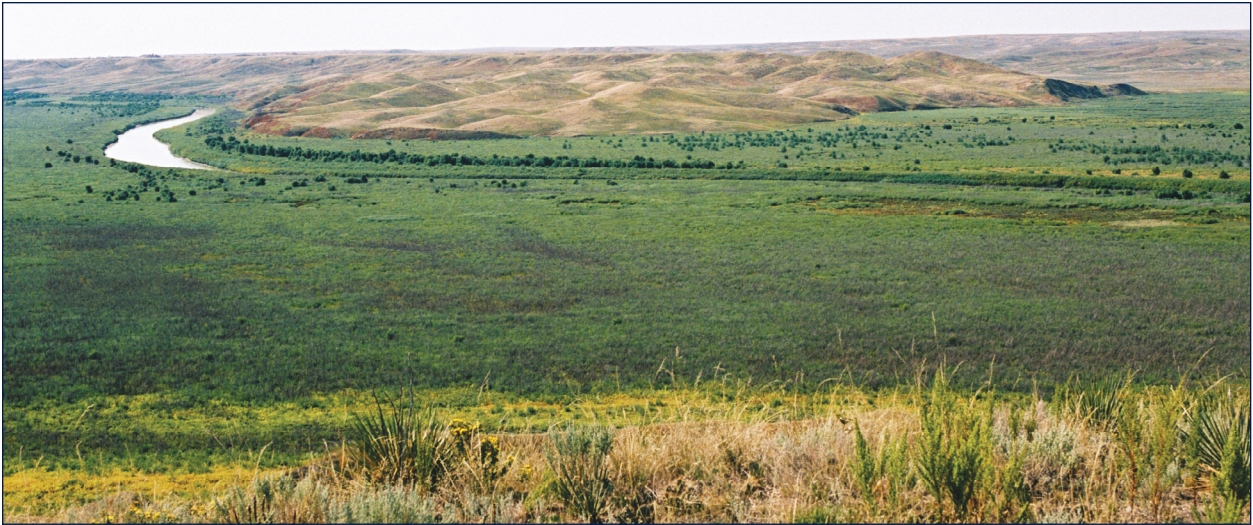
Figure 14. View of the Cheyenne River delta (September 2008) looking west from the Mortenson Ranch Home Place during low water levels of Oahe Reservoir. The Cheyenne River channel is in view along with scattered trees. The vegetation matrix is primarily sandbar and peachleaf willows.

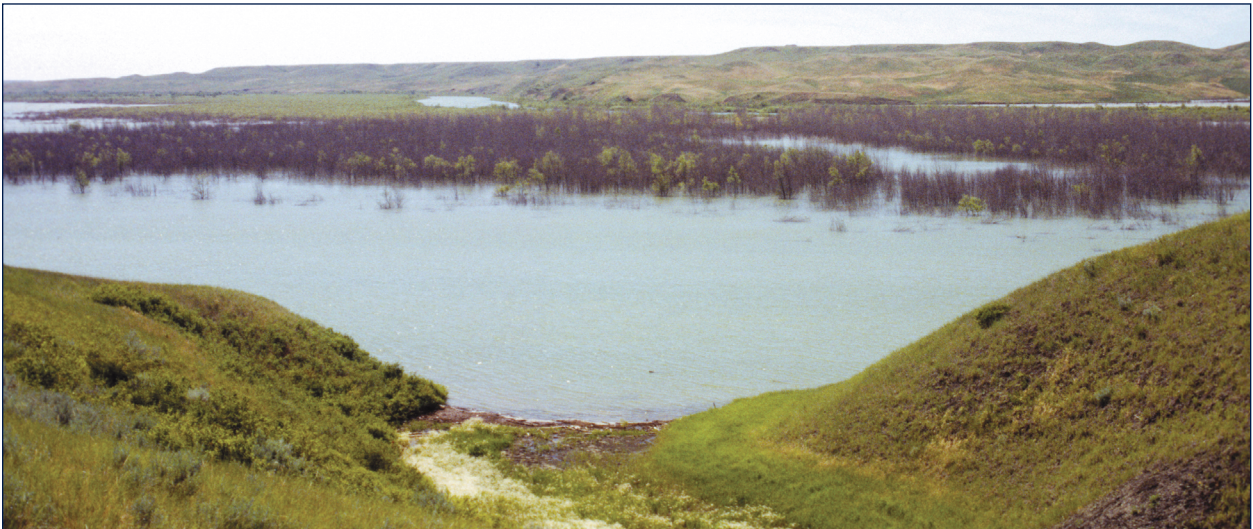
Figure 15. View of the Cheyenne River delta (July 1997) looking west from the Mortenson Ranch Home Place during high water levels of Oahe Reservoir. Most established vegetation is either dead or dying from prolonged submergence.

The pre-dam Cheyenne River forests at the ranch were all killed by the reservoir water, as was the use of the floodplain as protective shelter for cattle. Because water levels in the reservoir vary by as much as 40 feet between periods of drought and deluge, and that the ranch occurs near the maximum pool level of the reservoir, their former bottomland dries out occasionally. During the dry periods, dense riparian vegetation including young cottonwood and willow trees re-establishes (Figure 14). However, this new growth is flooded and destroyed once the reservoir recovers to full pool levels (Figure 15). In short, this long reach (37 miles) of the Cheyenne River floodplain, that has been re-constituted into an alluvial delta has collected over 50 feet of sediment in lower sections (Volke et al. 2015). It no longer reliably provides the shelter for domestic stock, wildlife, and human occupation that it did in the past (Figure 16).

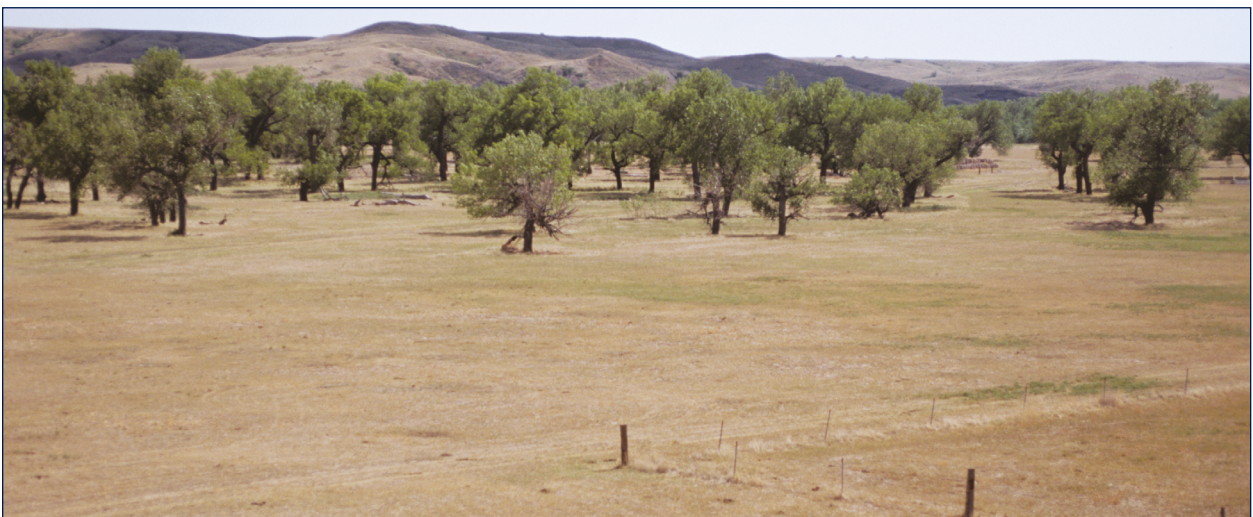
Figure 16. Sample of what the Cheyenne River bottoms of the Mortenson Ranch looked like before being flooded out by Oahe Reservoir. This photograph taken in July, 2002 shows the Cheyenne River floodplain far enough upstream of the Oahe Reservoir to not be affected by it.

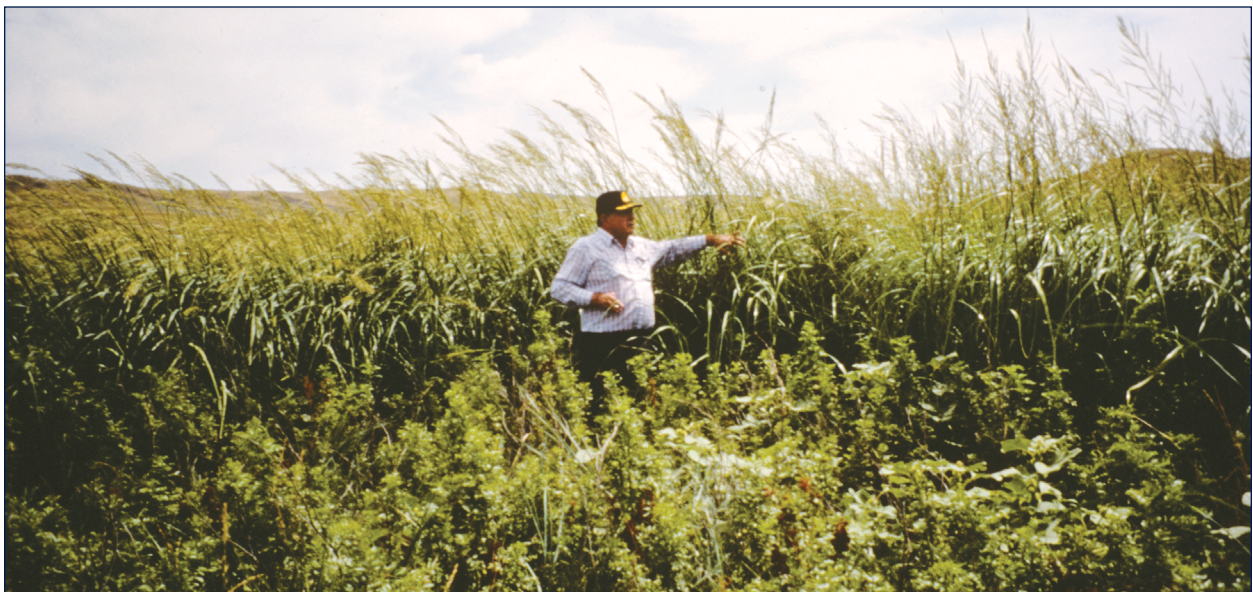
Figure 21. Prairie cordgrass establishment along Foster Creek following rehabilitation work. Clarence Mortenson is standing next to a tall and dense sward.

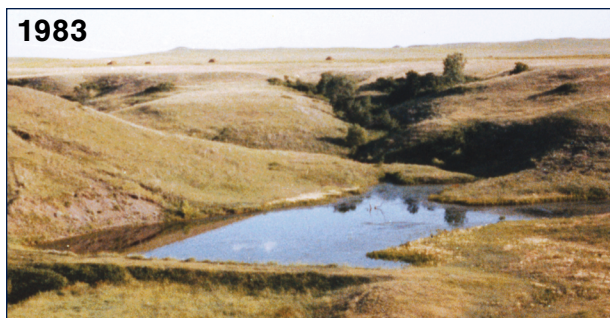
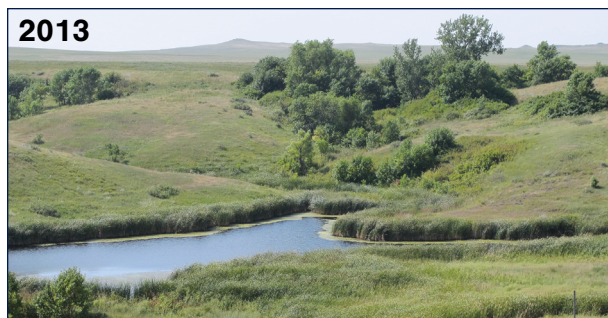
Figure 23a. Photographs of site #1 taken at two time periods, 1983 (left) and 2013 (right) on the Mortenson Ranch Home Place.

in each of the five woody draws in 1992-1994 using methods appropriate for each life form. Transect end and middle points were permanently marked with rebar pins and re-sampled twice at approximately seven year intervals. Photographs of each sampled draw were taken from permanent photo points at similar time intervals (Figure 23a-e). GPS coordinates for transects and photo points are provided in Appendix Table 2.

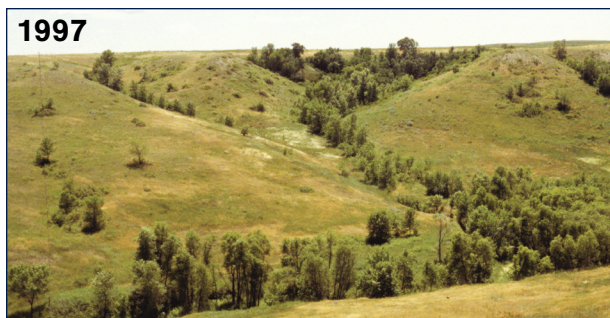
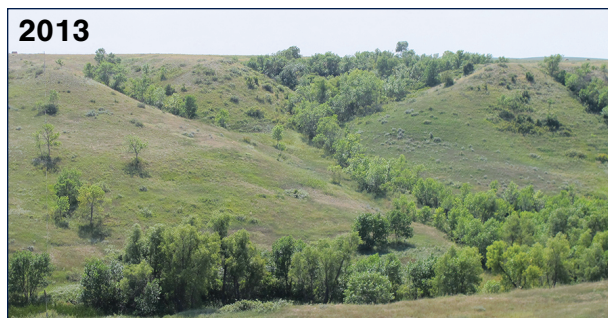
Figure 23b. Photographs of site #2 taken at two time periods, 1997 (left) and 2013 (right) on the Mortenson Ranch Home Place.

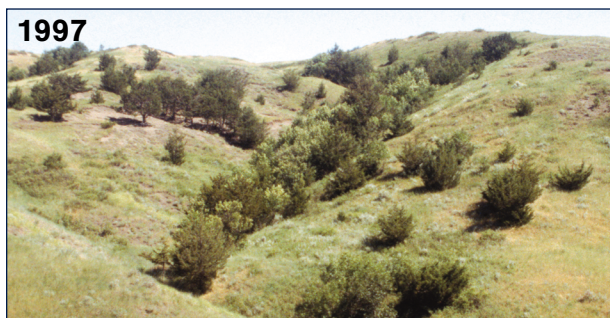
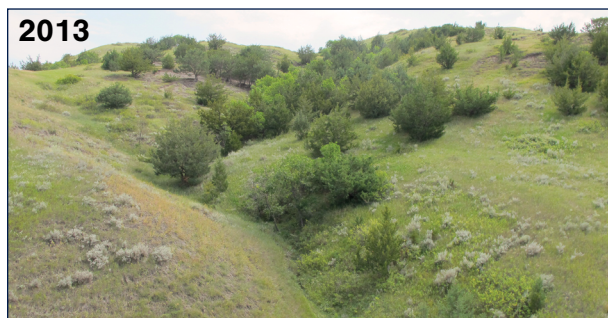
Figure 23c. Photographs of site #3 taken at two time periods, 1997 (left) and 2013 (right) on the Mortenson Ranch Home Place.

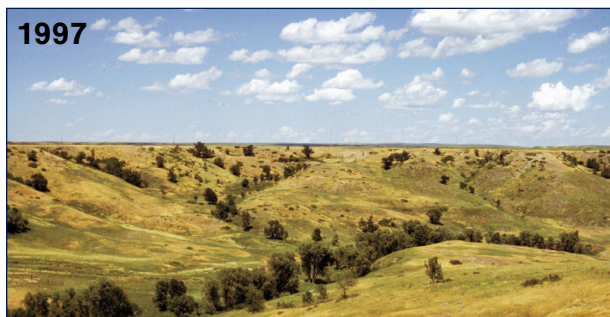
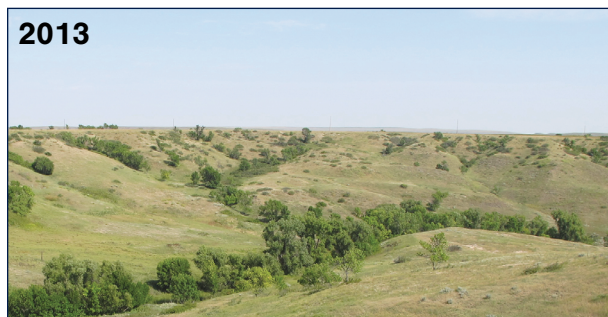
Figure 23d. Photographs of site #4 taken at two time periods, 1997 (left) and 2013 (right) on the Mortenson Ranch Home Place.

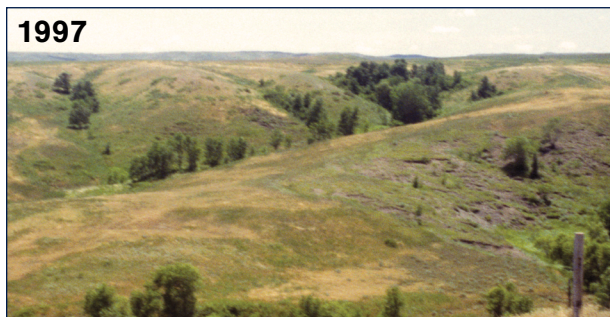
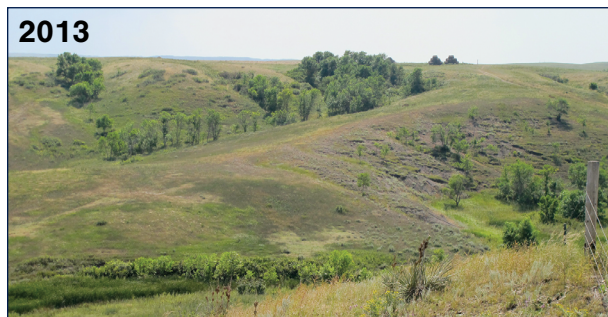
Figure 23e. Photographs of site #5 taken at two time periods, 1997 (left) and 2013 (right) on the Mortenson Ranch Home Place.

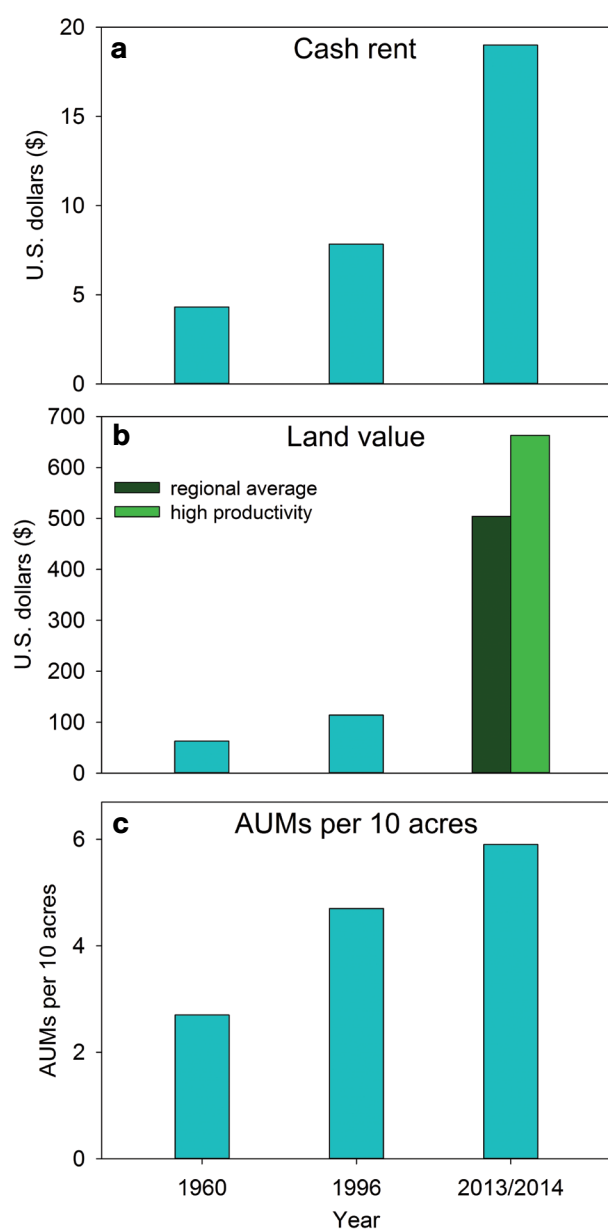
Figure 29a. Cash Rent per acre changes applicable to the Mortenson Ranch. The 1960 and 1996 data (averaged for the three ranch parcels) were from Boettcher et al. (1998). The basis for the 1996 cash rent estimate was \$16.50 per AUM. The 2013 estimate was calculated using the basis of \$32.15 per AUM (average of the southwest and northwest South Dakota survey regions from Janssen et al. 2014) and actual AUM values in Fig 29c.
